## Trials in succession woodland planting at SENT Landfill, Tseung Kwan O

Barry Wilson

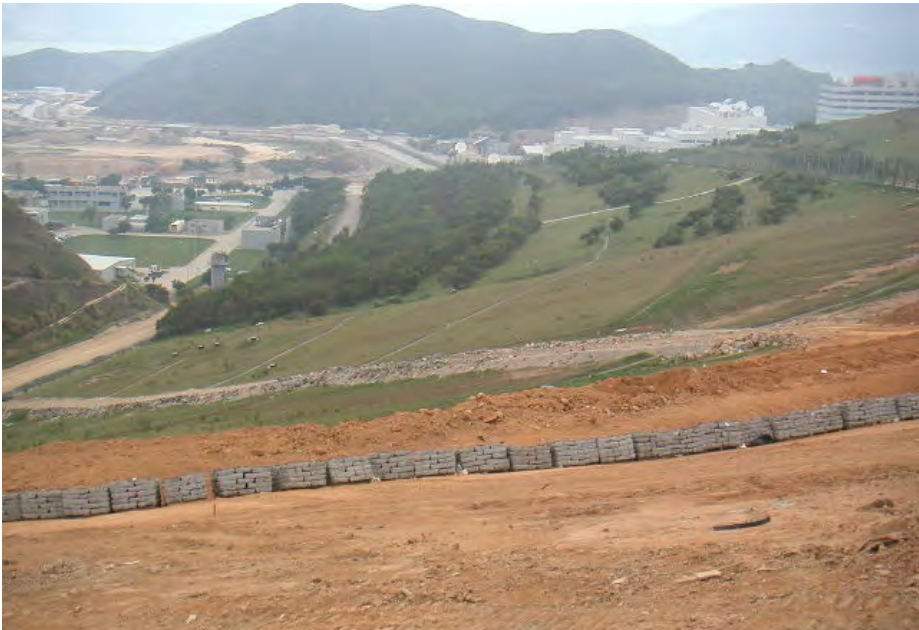
2003 - Restoration Phases 1-4. Phased planting blocks can be clearly identified as the landfill grows.

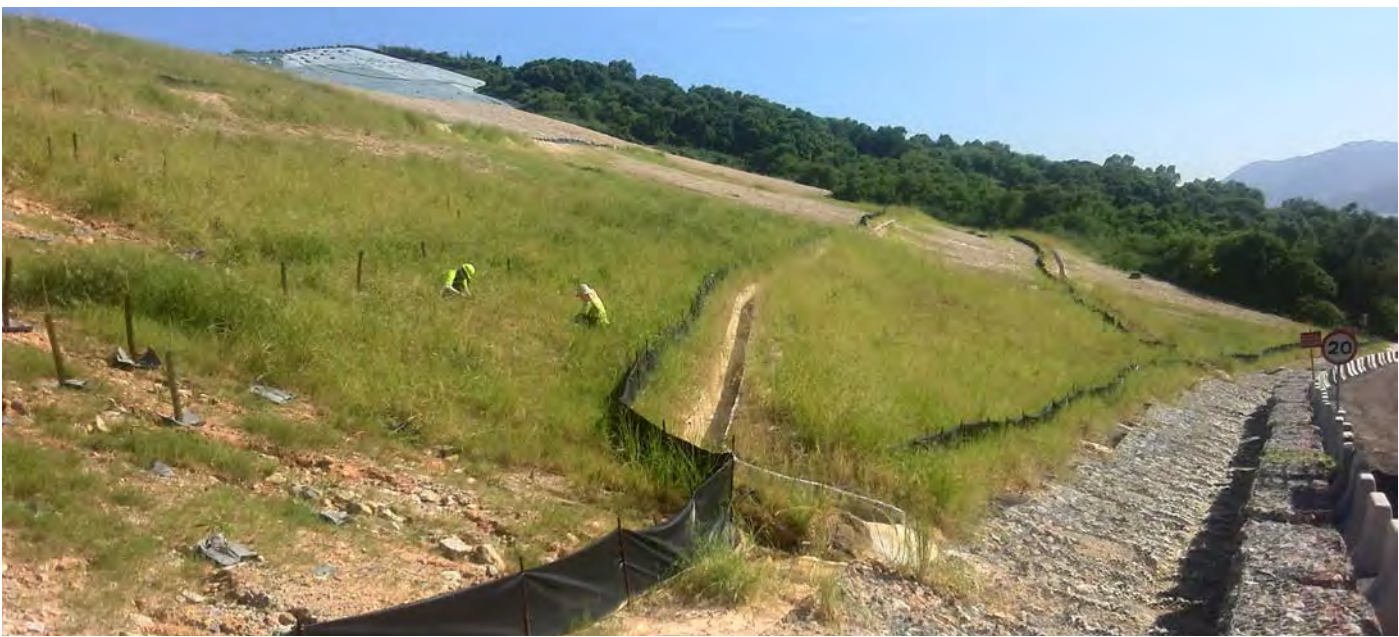
2014 - Erosion problems have affected the success of hydroseeding in some areas. Newly planted delicate species in microclimatic growth tubes can be seen with early phase woodland in the background.

Following the continued disappointing results in establishing native trees within the restoration, a new approach has been considered since the 7th phase of planting (undertaken in 2010) whereby approximately 10% of plants were installed with microclimatic growth tubes (MGTs), as a trial. A detailed review was carried out in August 2011 to ascertain the effect of the tubes and whilst there were some positive indications for some species, the conclusions were hard to draw due to the small sample size. As such, wider and more stringent trial monitoring has now been established over the last three planting phases combined with the introduction of weed mats.

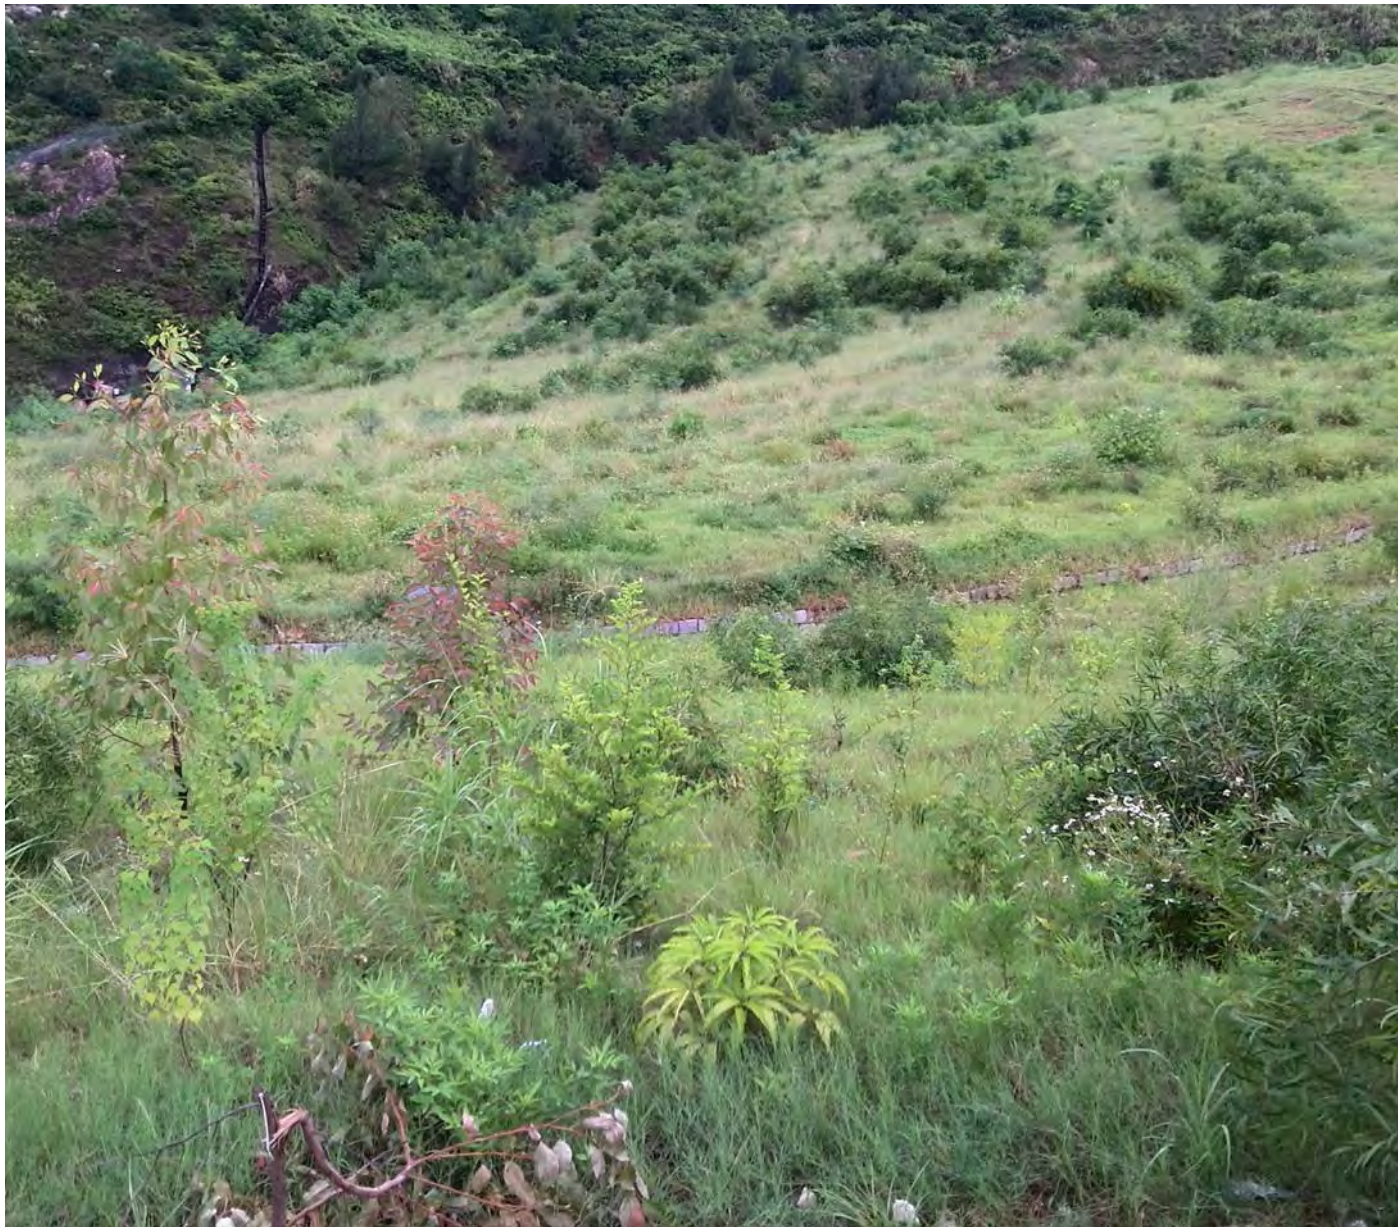
2014 - Restoration phase 9. One year into establishment. Phase 7 planting blocks can be seen at the rear.

Phased planting currently being undertaken has essentially followed the 6 species block matrix utilising clustered blocks of 25 plants spaced at 1500mm with some revisions to the species included above.

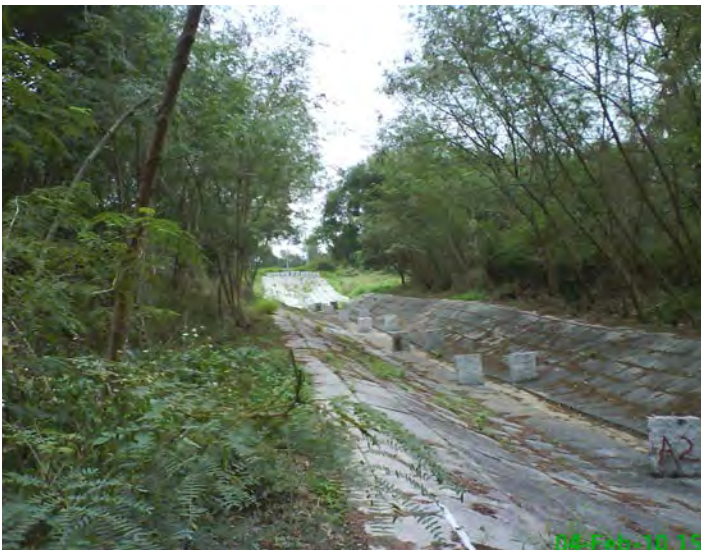
2010 - Woodland planting about 10 years old. *Leucaena* has started to invade the light pockets and woodland margins.

Large numbers of invasive *Leucaena leucocephala* have become an increasing problem on the landfill in recent years, taking a hold on both temporary fill areas and final restoration slopes. They are particularly problematic in areas of tree planting as they colonise en-masse, compete with seedlings for the valuable soil water and crowd out new plantations. If not continually removed at the earliest possible moment their removal becomes increasingly difficult as they become too large to be pulled by hand. Whilst they were initially viewed positively in their ability to colonise the landfill, their profuse seeding is now a major concern.

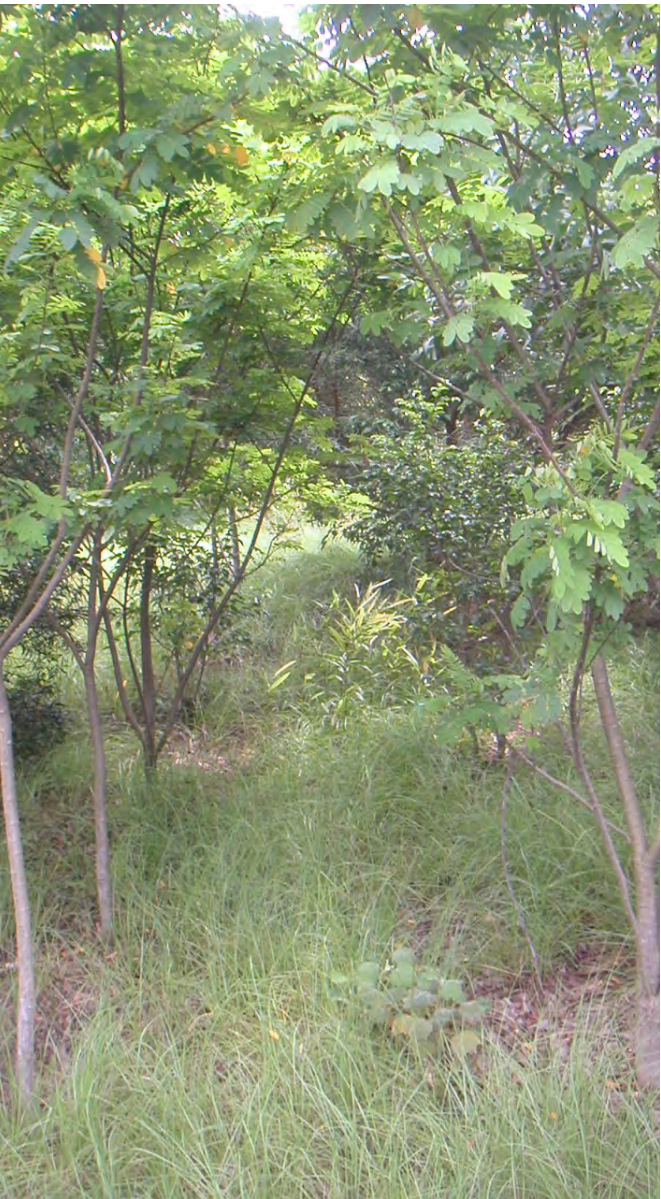
2004 - A mixed canopy established. Grass cutting can be suspended and the woodland left to develop.

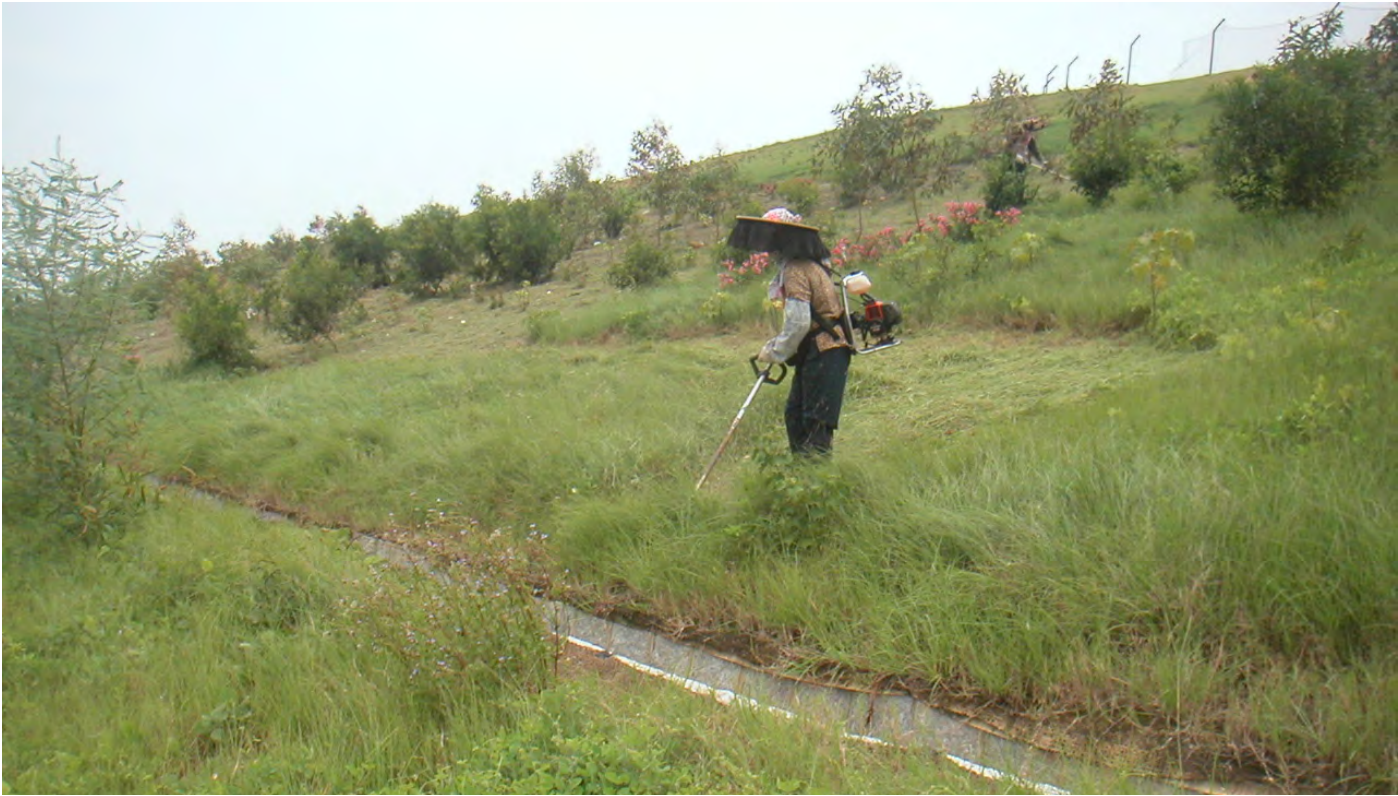
2004 - Weed suppression in planting blocks is essential in the early years of woodland development
